Medical Devices: The Therac-25*

Nancy Leveson
University of Washington

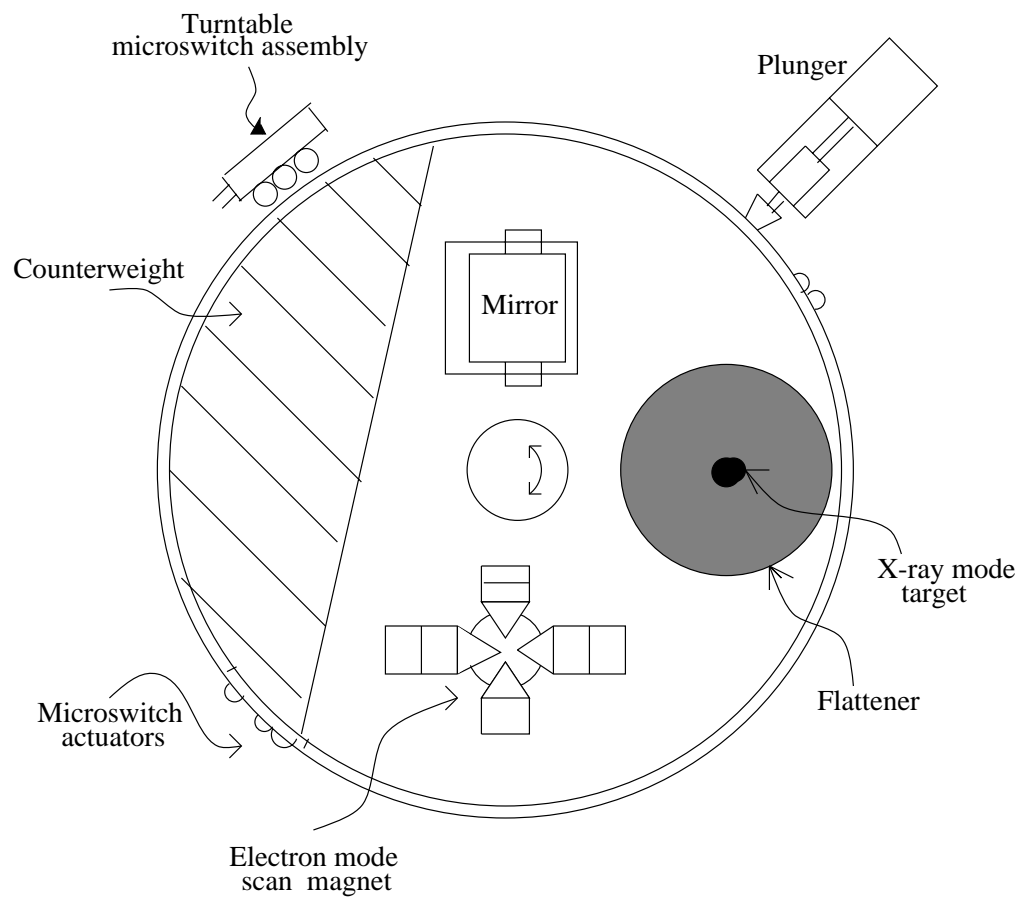
Figure 1: Upper turntable assembly.

Turntable Positioning. The Therac-25 turntable design plays an important role in the accidents. The upper turntable (see Figure 1) rotates accessory equipment into the beam path to produce two therapeutic modes: electron mode and photon mode. A third position (called the field light position) involves no beam at all, but rather is used to facilitate correct positioning of the patient. Because the accessories appropriate to each mode

are physically attached to the turntable, proper operation of the Therac-25 is heavily dependent on the turntable position, which is monitored by three microswitches.

The computer senses and controls turntable position by reading a 3-bit signal about the status of three microswitches in the turntable switch assembly. Essentially, AECL determined that a 1-bit error in the microswitch codes (which could be caused by a single open-circuit fault on the switch lines) could produce an ambiguous position message to the computer. The problem was exacerbated by the design of the mechanism that extends a plunger to lock the turntable when it is in one of the three cardinal positions: The plunger could be extended when the turntable was way out of position, thus giving a second false position indication. AECL devised a method to indicate turntable position that tolerated a 1-bit error so that the code would still unambiguously reveal correct position with any one microswitch failure.

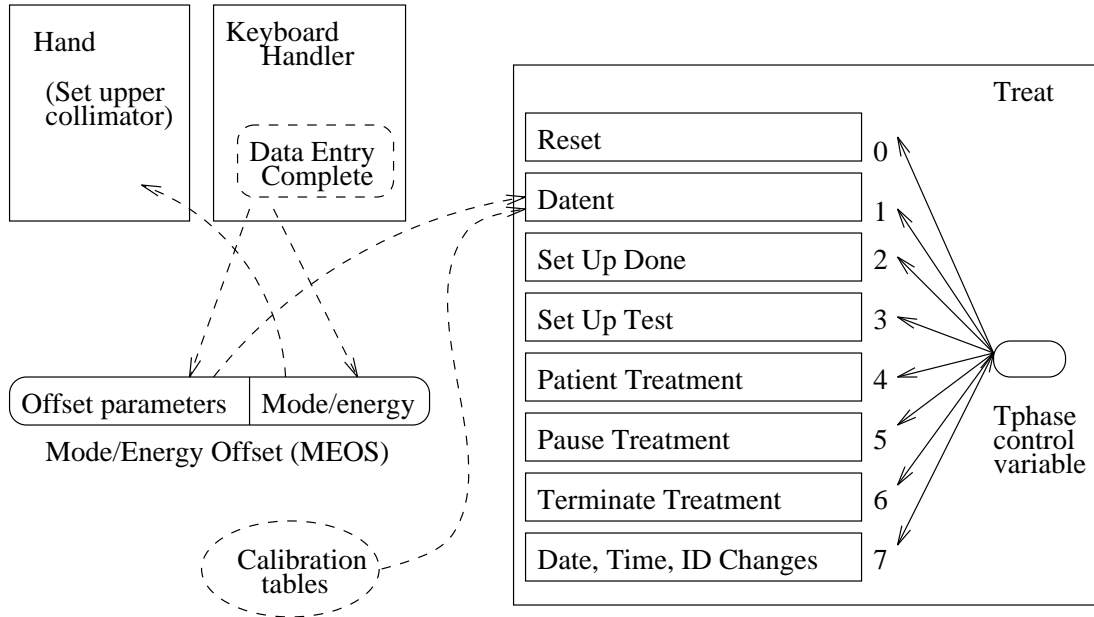
Figure 3: Tasks and subroutines in the code blamed for the Tyler accidents.

The treatment monitor task (Treat) controls the various phases of treatment by executing its eight subroutines. The treatment phase indicator variable (Tphase) is used to determine which subroutine should be executed (Figure 3). Following the execution of a particular subroutine, Treat reschedules itself.

But this is not the only problem. Upon exit from the Magnet subroutine, the data entry subroutine (Datent) checks the Data Entry Complete variable. If it indicates that data entry is complete, Datent sets Tphase to 3 and Datent is not entered again. If it is not set, Datent leaves Tphase unchanged, which means it will eventually be rescheduled. But the Data Entry Complete variable only indicates that the cursor has been down to the command line, not that it is still there. A potential race condition is set up. To fix this, AECL introduced another shared variable controlled by the keyboard handler task that indicates the cursor is not positioned on the command line. If this variable is set, then prescription entry is still in progress and the value of Tphase is left unchanged.

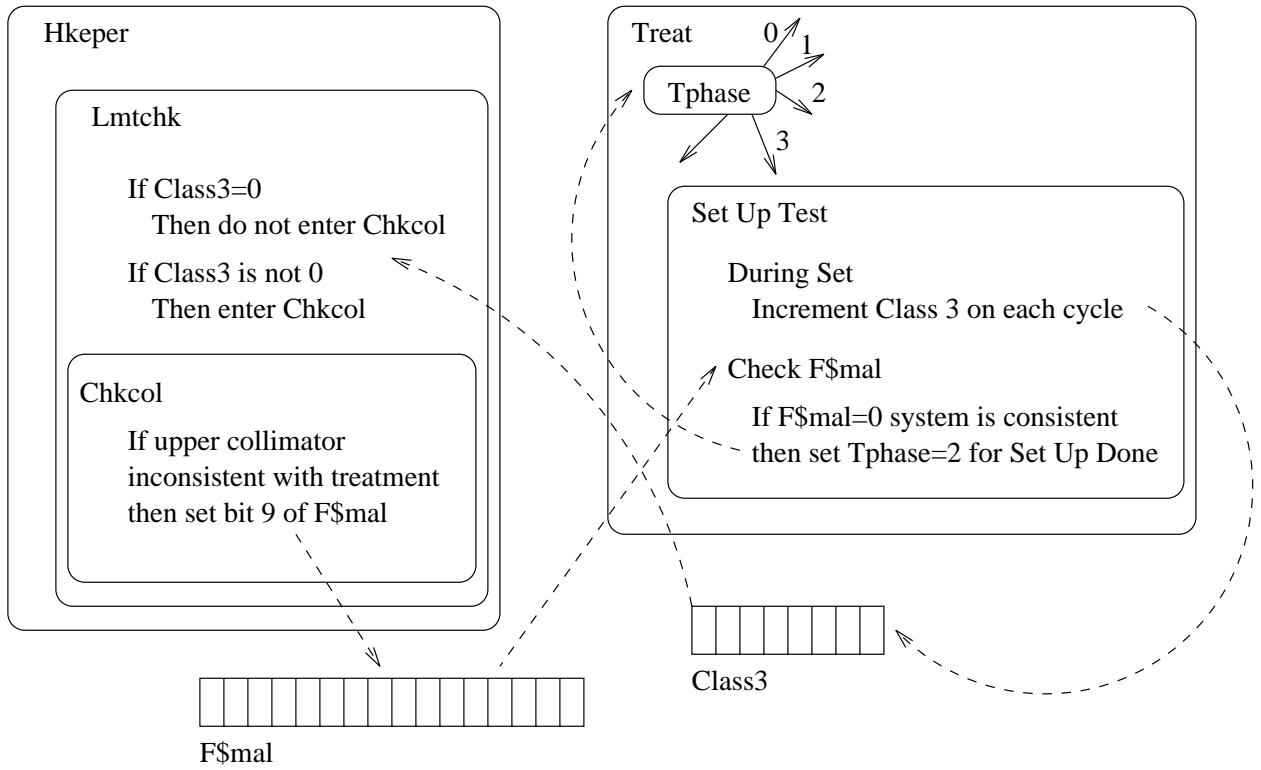
Figure 4: The Yakima software flaw.

The second Yakima accident was again attributed to a type of race condition in the software — this one allowed the device to be activated in an error setting (a “failure” of a software interlock). The Tyler accidents were related to problems in the data-entry routines that allowed the code to proceed to Set Up Test before the full prescription had been entered and acted upon. The Yakima accident involved problems encountered later in the logic after the treatment monitor Treat reaches Set Up Test.

The overexposure occurred when the operator hit the “set” button at the precise moment that Class3 rolled over to zero. Thus, Chkcol was not executed and F\$mal was not set to indicate that the upper collimator was still in the field-light position. The software turned on the full 25 MeV without the target in place and without scanning. A highly concentrated electron beam resulted, which was scattered and deflected by the stainless
