Medical Devices: The Therac-25*

Nancy Leveson
University of Washington

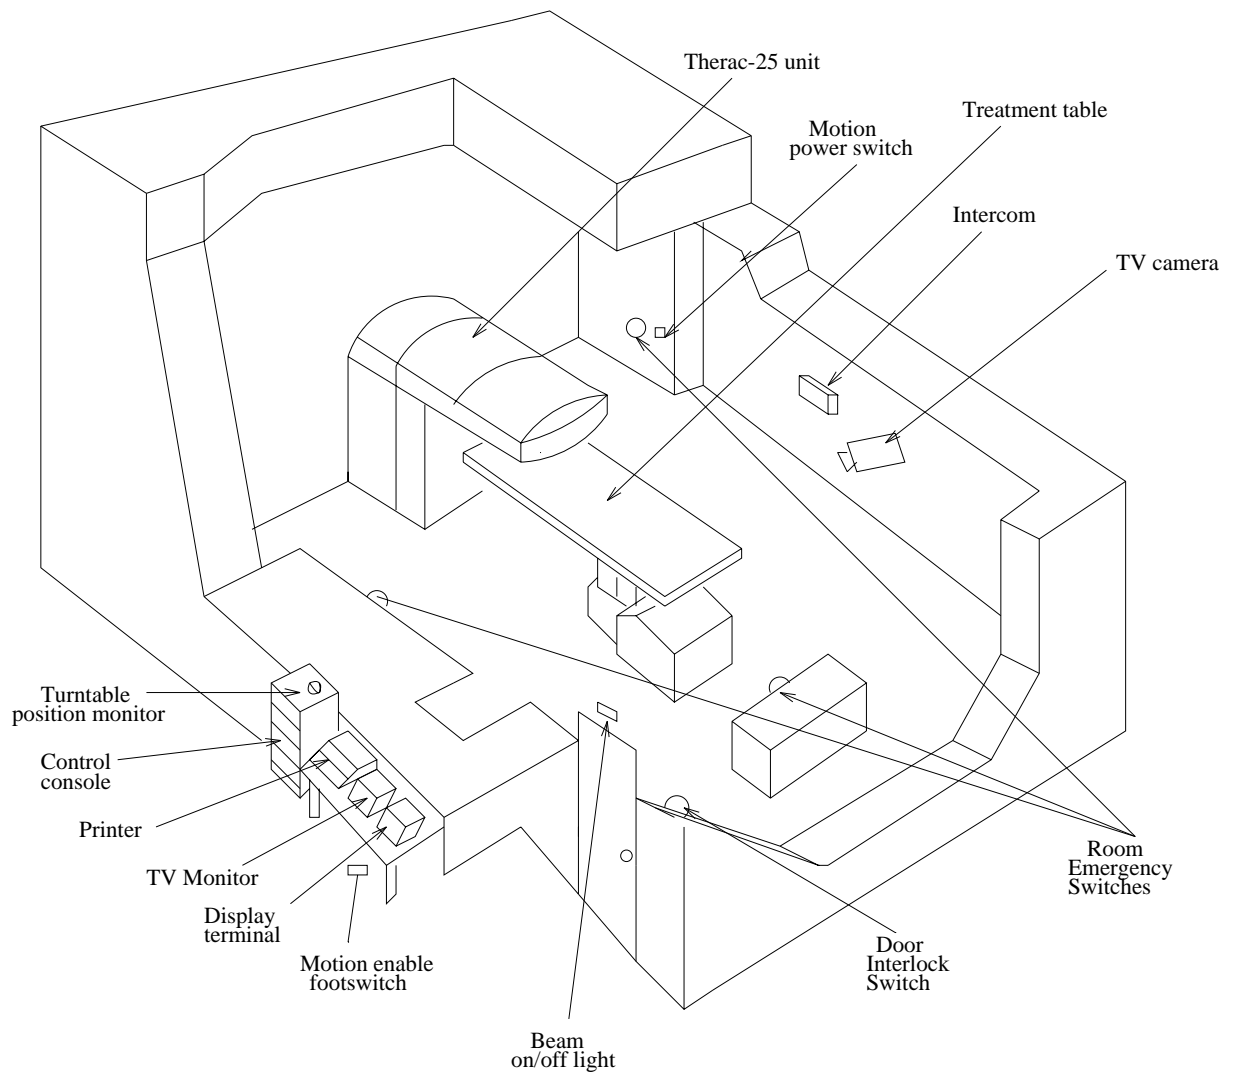
Figure 5 shows a typical Therac-25 installation after the CAP changes were made.

Figure 5: A typical Therac-25 facility after the final CAP.

- Beam-on will be prevented if the turntable is in the field light or any intermediate position.
- Cryptic malfunction messages will be replaced with meaningful messages and highlighted dose-rate messages.

- The known software problems associated with the Tyler and Yakima accidents will be fixed.
- The manuals will be fixed to reflect the changes.
